Drive Shaft Repair Kits

Best range in the Aftermarket with over 20 References

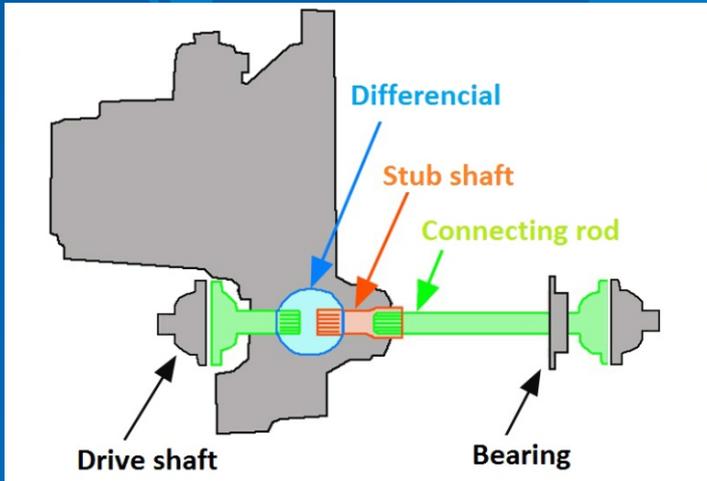
Stub shafts are a unique development of VAG which can be found mainly in Transporter and Van applications.

The stub shaft transfers torque, absorbs vibrations and compensates length differences during suspension deflection to the drive shaft.

As the stub shaft is exposed to environmental conditions and the outer splines are not covered by a boot, the wear of splines of stub and driveshaft is the main reason for vibrations and noises.

It is important to change the worn drive shaft together with the connecting stub shaft. If not, vibrations and noises occur provoked by the worn toothings of the old part. In case that only one part has been changed, the claims will come up again after short time. GSP now provides kits containing drive shaft and corresponding stub shaft to offer a service solution for workshops, which lowers the rework rate and allows a clever part replacement.
